Roadway Conceptual Analysis for Chuluota Road (CR 419) From SR 50 to Lake Pickett Road

Chuluota Road (CR 419) FROM SR 50 TO LAKE PICKETT ROAD

Orange County Project Number: Y20-830

REPORT: Roadway Conceptual Analysis Report

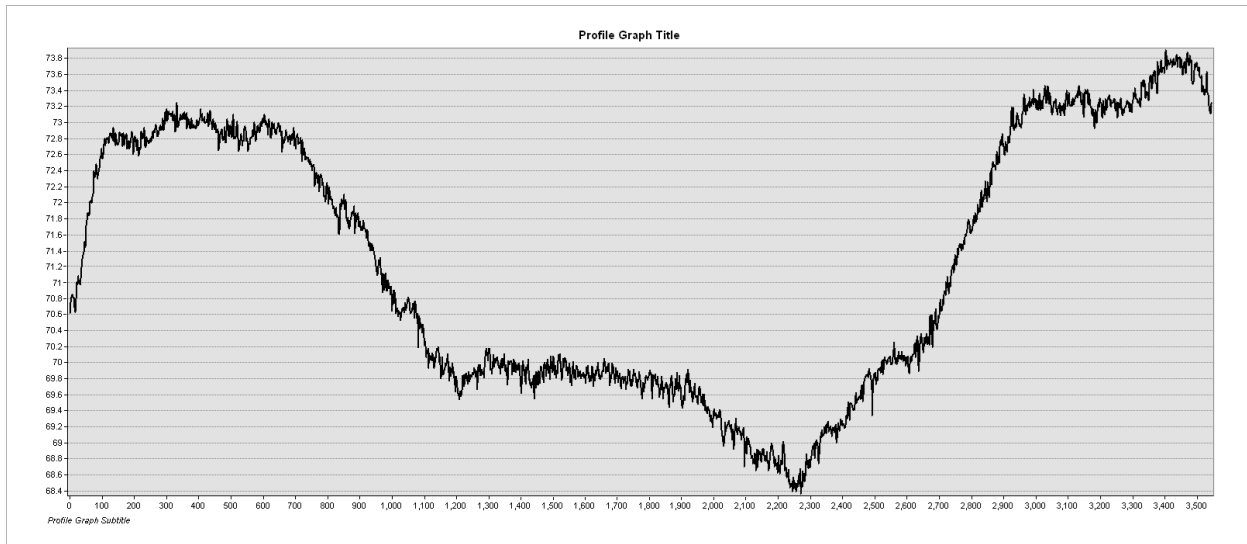
**Figure 3-2 Existing Roadway Profile
from LiDAR
SR 50 to Lake Pickett Road**

The existing ground profile of Chuluota Road is reflected below on Figure 2-2 which indicates a starting elevation of approximately 70 feet at SR 50. The existing profile then rises to an elevation of approximately 73 feet just south of Schoolview Way. The roadway then steadily drops between Cypress Lake Glen Boulevard to the north of Corner Lake Drive before reaching an elevation of approximately 69 feet. The Chuluota Road grade then rises to an elevation of approximately 73.5 feet at Lake Pickett Road. It is noted that the information presented in the section is based on Orange County LiDAR information which utilizes the NAVD88 datum.

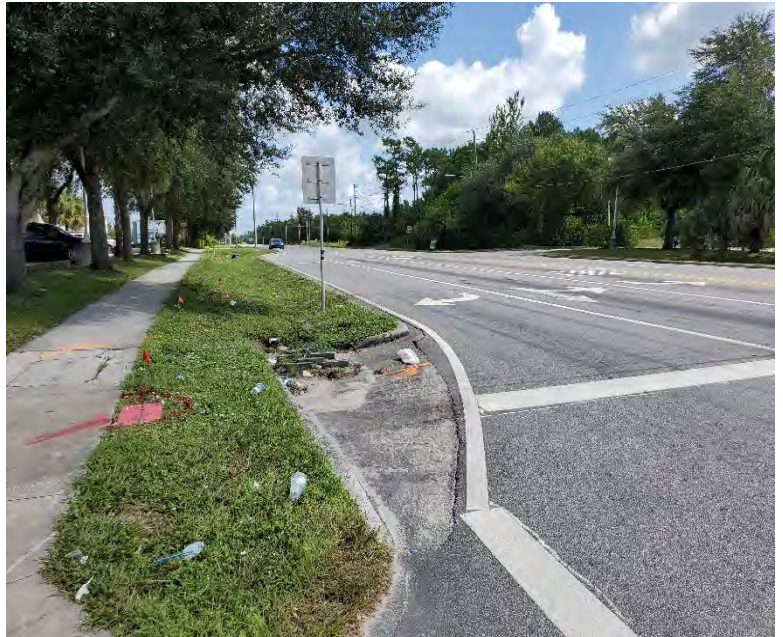
Stormwater runoff is conveyed by a ditch into an existing FDOT storm drain system draining west along SR 50. There is no existing stormwater attenuation or water quality treatment.

Existing inlet drains west into FDOT SR 50 ROW

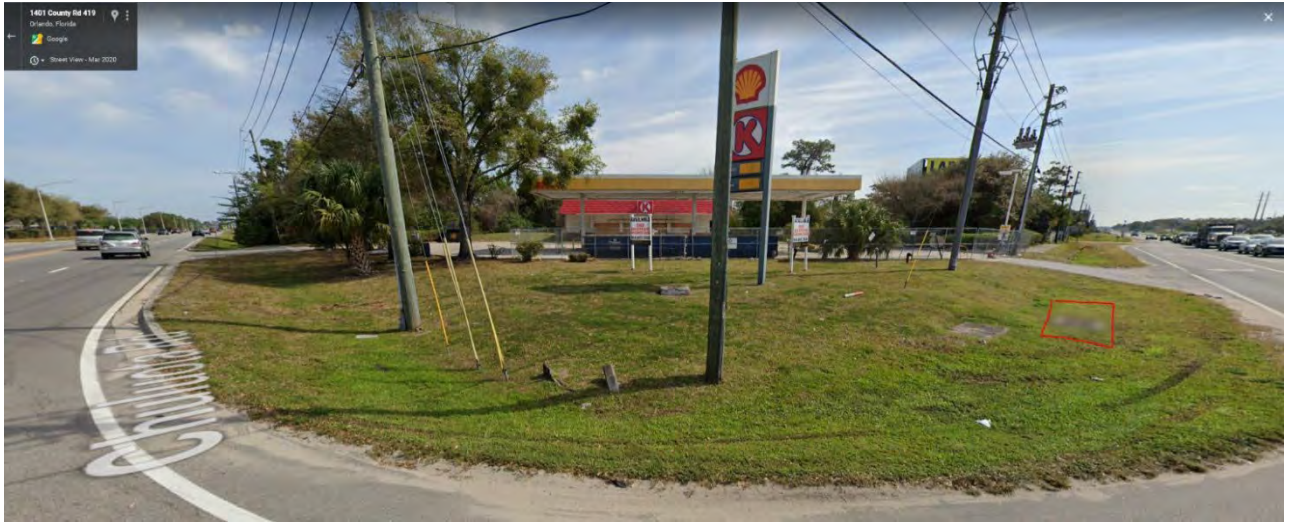
Stormwater runoff sheet flows into the existing FDOT storm drain system draining east along Colonial Blvd. There is no existing stormwater attenuation or water quality treatment.

Existing inlet on east side of Chuluota Road drains into FDOT SR 50 ROW

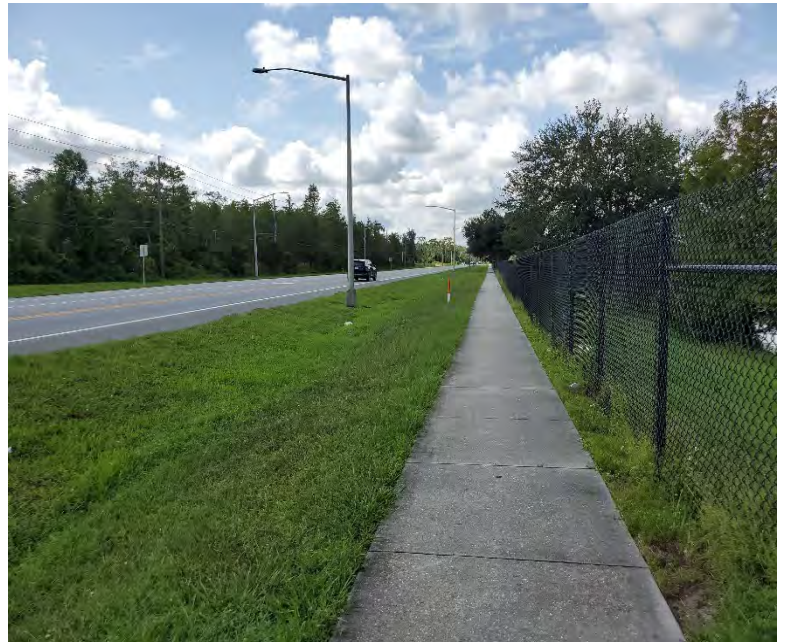
County LiDAR indicates that Basin 2A ranges in elevation from 70 feet to 73 feet (mean 72.0 feet). Stormwater runoff sheet flows into a ditch which is conveyed via a ditch bottom inlet and storm drain into the existing pond north of intersection of Schoolview Way and Chuluota Road (ERP#27857).

Roadside ditch facing south

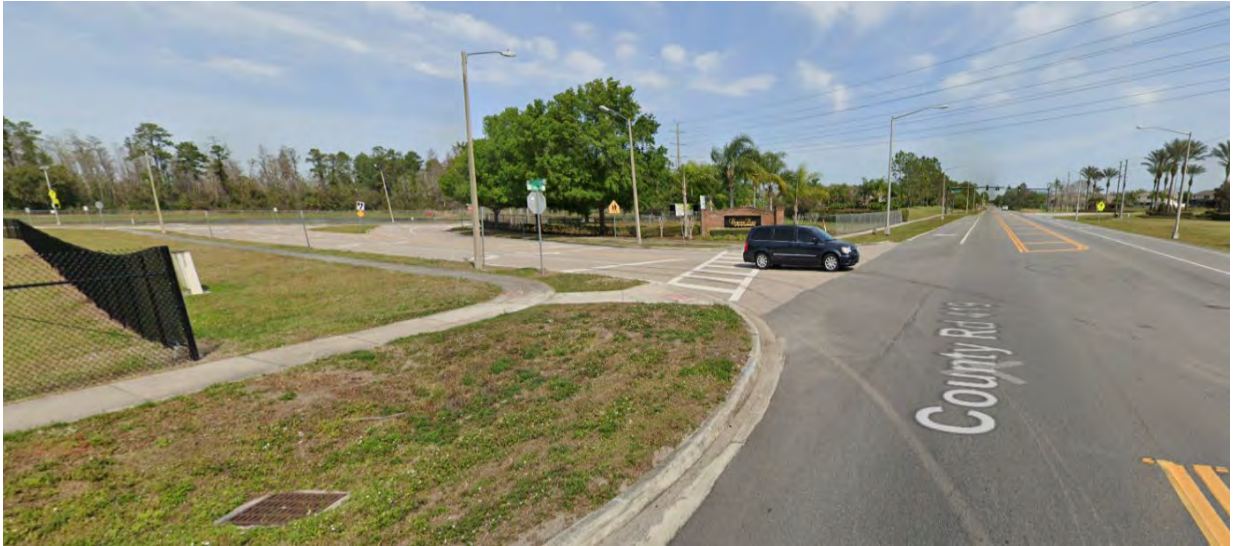
Chuluota Road and Schoolview Way showing ditch bottom inlet which drains to existing pond

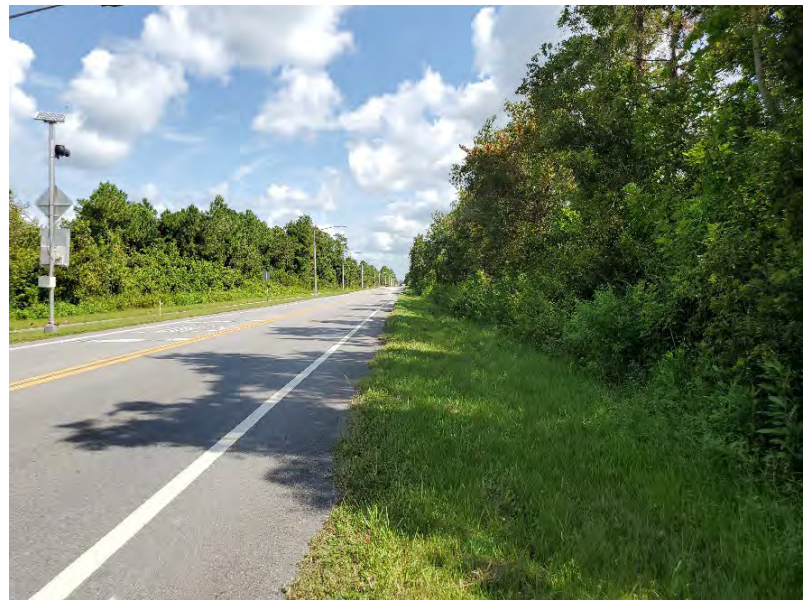
County LiDAR indicates that Basin 2B ranges in elevation from 66.7 feet to 73.5 feet (mean 70.7 feet). Stormwater runoff sheet flows into adjacent roadside ditches that flow towards an existing cross drain (CD-1). The existing cross drain flows toward the wetland system to the west of Chuluota Road. A side drain under Corner Lake Drive conveys this runoff to wetlands west of Chuluota Road in Basin 3.

Roadside ditch facing north

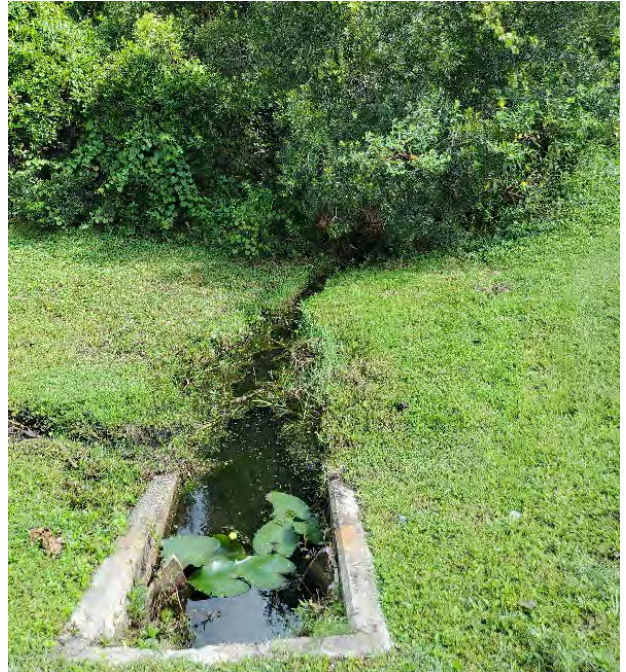
The existing cross drain drains to a relict wetland canal west of Chuluota Road which ultimately discharges to Corner Lake.

Existing side drain under Corner Lake Drive which conveys runoff from Basin 2B to Basin 3

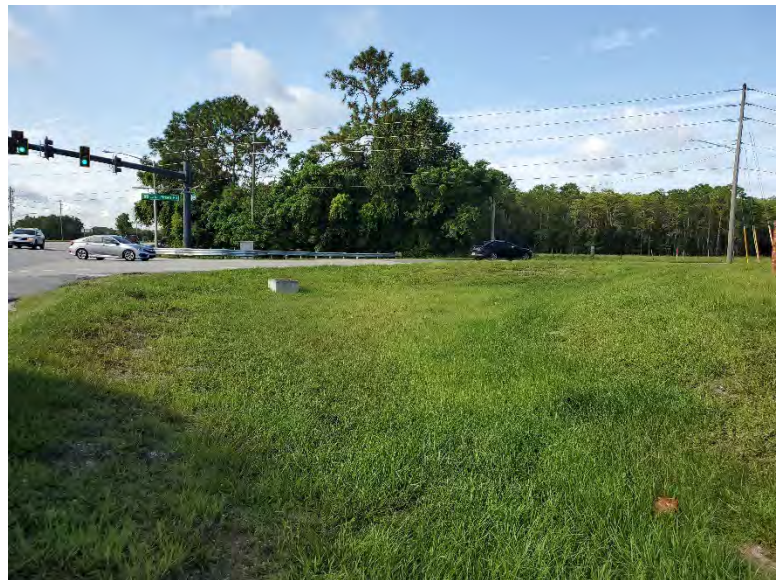
Existing dry pond northeast of Lake Pickett Road and Chuluota Road

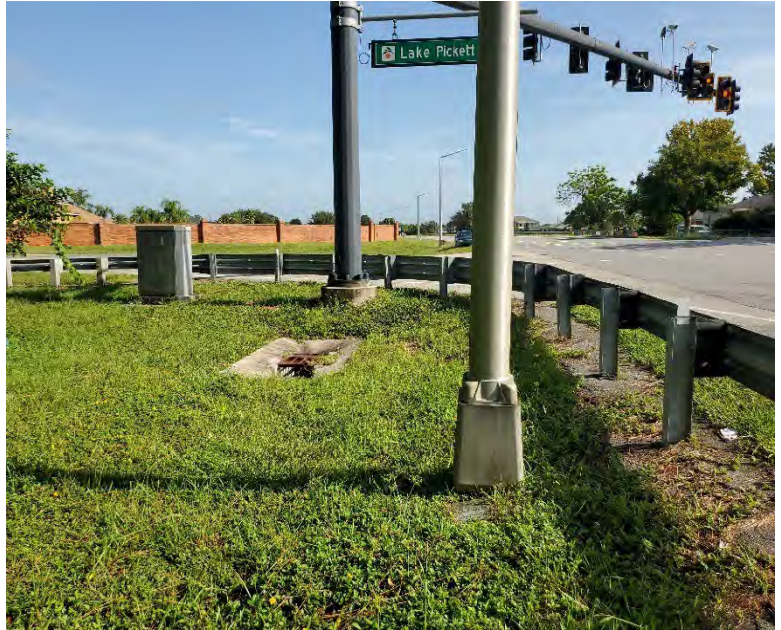
Ditch bottom inlet at southwest intersection of Lake Pickett Road and Chuluota Road, facing north

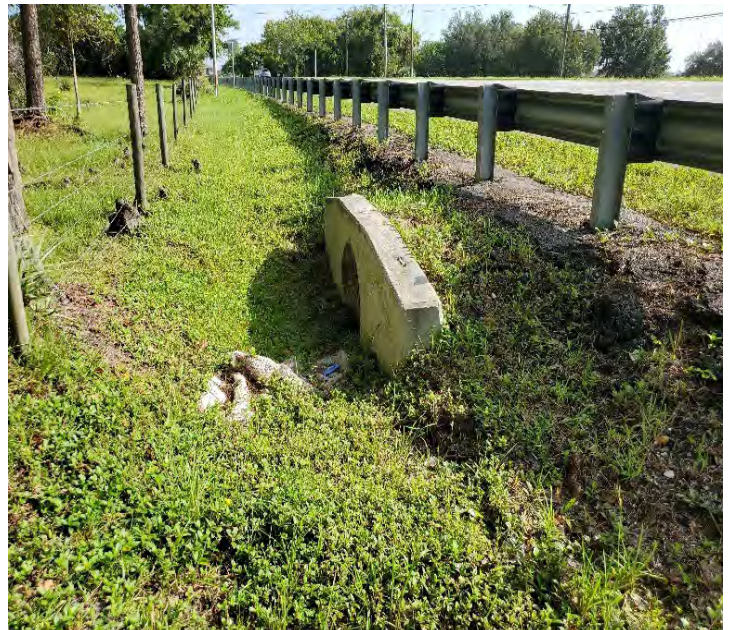
Cross drain which conveys runoff from basin 4-300 to storm drain on east side of Chuluota Road, facing north and east.

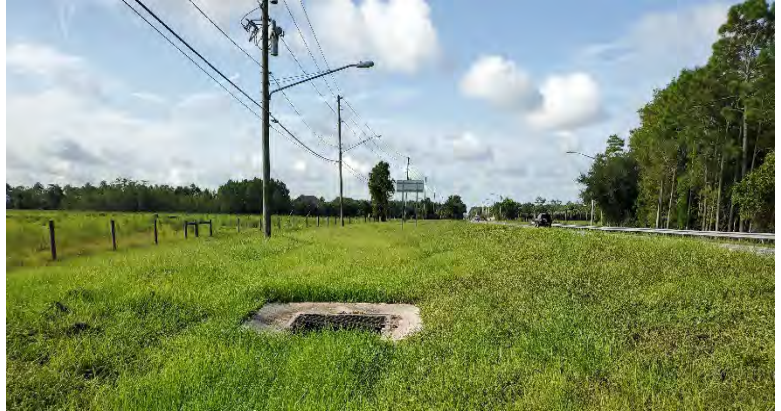
Runoff is conveyed via sheet flow to a roadside ditch which drains to a cross drain under Chuluota Road. That cross drain conveys runoff to a storm drain on the east side of Chuluota Road (in Basin 4-400). Runoff is ultimately conveyed to the existing storm drain system along Lake Pickett Road to wet detention ponds associated with the Mandalay Subdivision (ERP#101908-1, -2, and -4).

Ditch bottom inlet which conveys sheet flow from Chuluota Road to existing storm drain, facing south
